DEPARTMENT OF THE ARMY
UNITED STATES ARMY AVIATION TEST BOARD
Fort Rucker, Alabama 36360

SUBJECT: ~~Letter Report~~ "Product Improvement Test, T53-L-11
Metal Spray Repaired Engine," ~~ADT&E~~ Project No.
5-0151-13, USATECOM Project No. 4-

ENGINEERING ANALYSIS

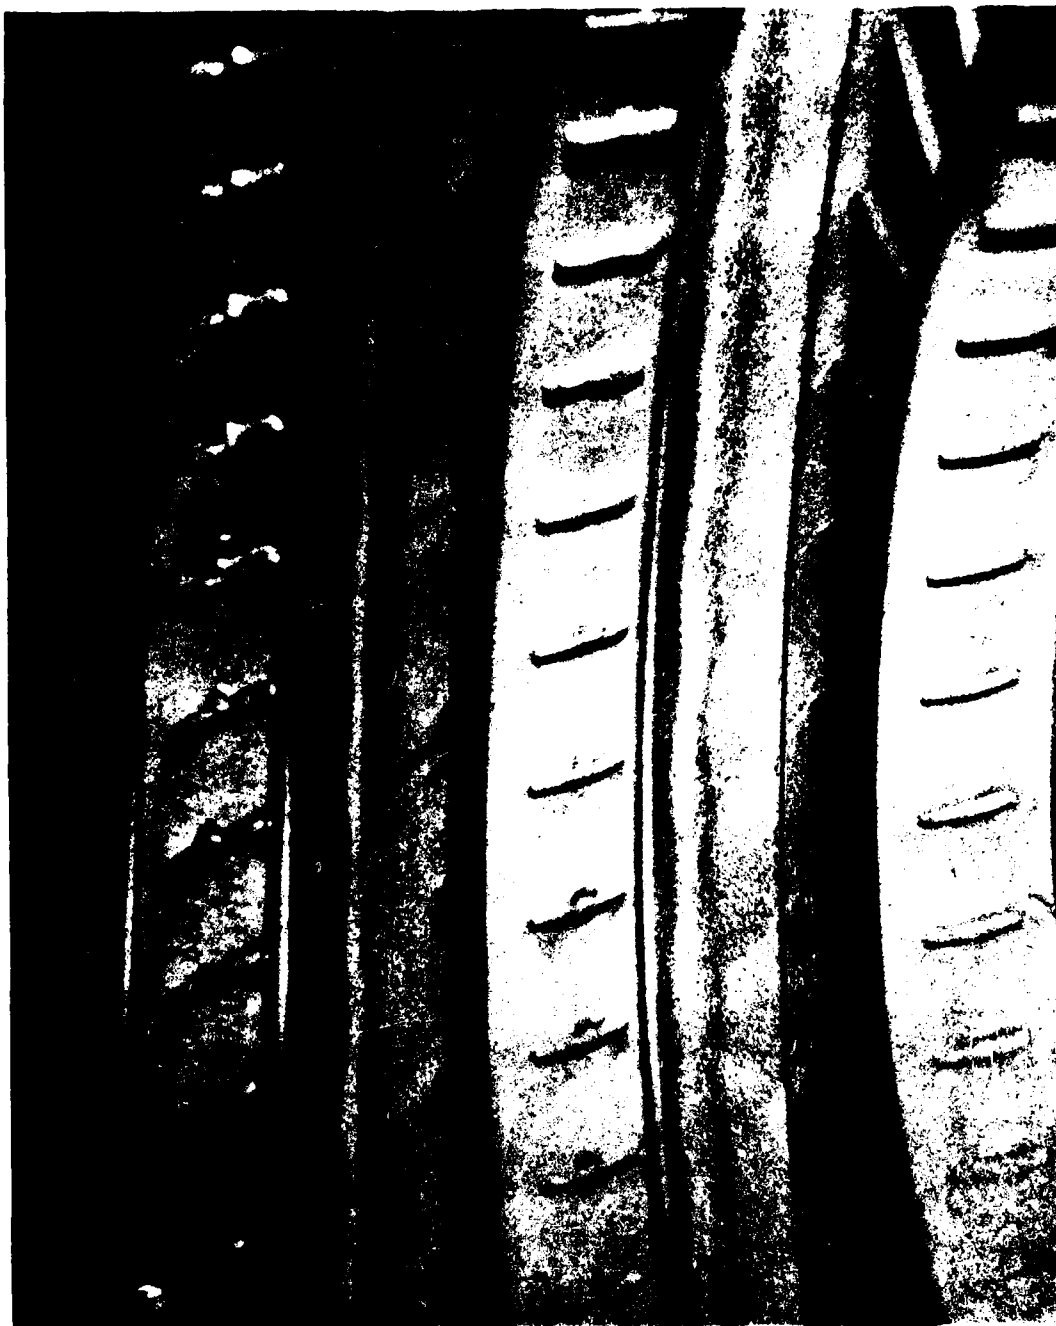
Figure 10.

1. The top case of the compressor was removed for inspection at 53.0 engine hours (1.5 sand hours). Only very minor erosion had occurred to the compressor blades and vanes. The general condition of the upper compressor case land areas is shown in figure 6 (left side, forward section), figure 7 (right side, forward section), figure 8 (left side, rear section), and figure 9 (right side, rear section). Figure 10 is a close-up photograph of the center section of the top case of the compressor at the second- and third-stage lands. Erosion, similar to that shown in figure 8, was evident on the leading edge of the third-stage land and to a minor degree on the second-stage land. The path of maximum erosion ran from the right forward portion of the upper compressor case counter-clockwise around to the left rear portion at the fourth-stage land. The erosion was not confined to this path alone, but was most highly concentrated along the described path.

upper compressor case land areas is shown in figure 11 (left side, forward section), figure 12 (right side, forward section), figure 13 (left side, rear section), and figure 14 (right side, rear section). Figure 15 is a close-up of the area shown in figure 10. The almost total disappearance of the erosion pits (shown in figure 10) along the leading edge of the third-stage land is evident in figure 15. This was because the leading edge of the metal spray land had initially extended further into the airstream than had the outer vane shrouds. The sand eroded the leading edge of the land until the land was flush with the vane outer shroud. Figure 16 shows the pitting that was beginning to develop on the leading edge of the fifth-stage land at the right rear of the upper compressor case. Figure 17 shows the trailing edge of the fifth-stage stators on the upper compressor case at the left side. The thinning of the outer trailing edges of the vanes is evident. Figure 18 shows the similar condition on the right side of the upper compressor case at the trailing edge of the fifth-stage stators. The general condition of the vanes and blades is shown in figure 19.

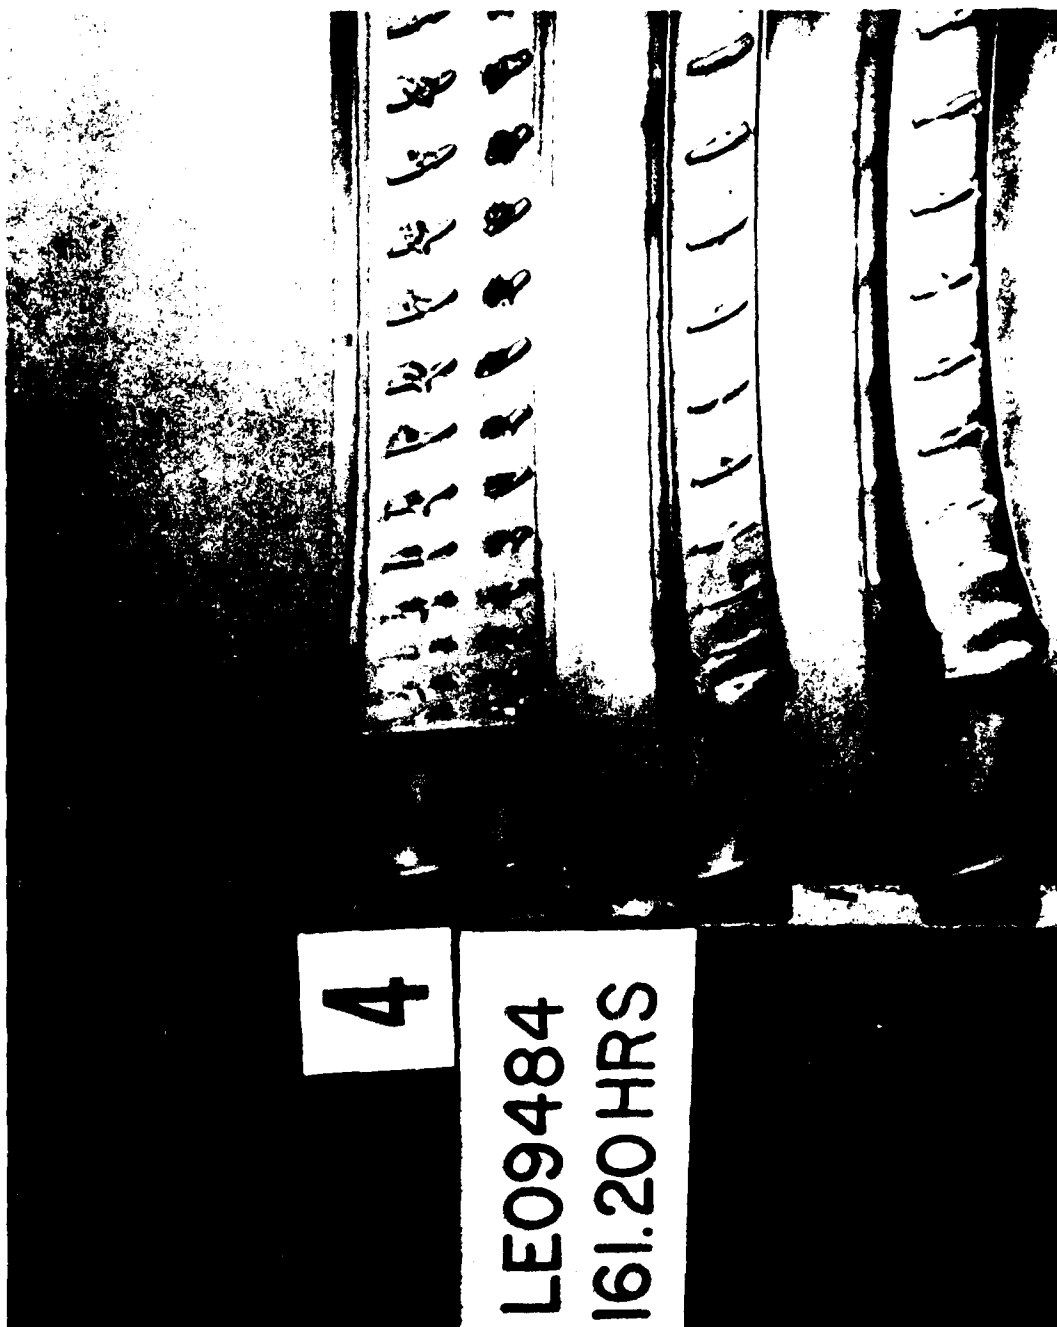
Figure 22.

3. The top compressor case was again removed and inspected at 161.2 engine hours (3.3 sand hours). The general condition of the top-half compressor lands is shown in figure 20 (left side, forward section), figure 21 (right side, forward section), figure 22 (left side, rear section), and figure 23 (right side, rear section). Figure 24 shows a center section of the third-, fourth-, and fifth-stage lands. Figure 25 shows the same area shown in figure 16. The pitting at the leading edge of the fifth-stage land had developed further. Figure 26 shows the general condition of the blades and vanes. Also observed at this inspection and pictured in figure 26 were erosion depressions (indicated by the arrow) in the lower compressor case aft of the second-stage stator vanes. The same area after 113.0 engine hours (2.2 sand hours) is indicated by the arrow in figure 19.

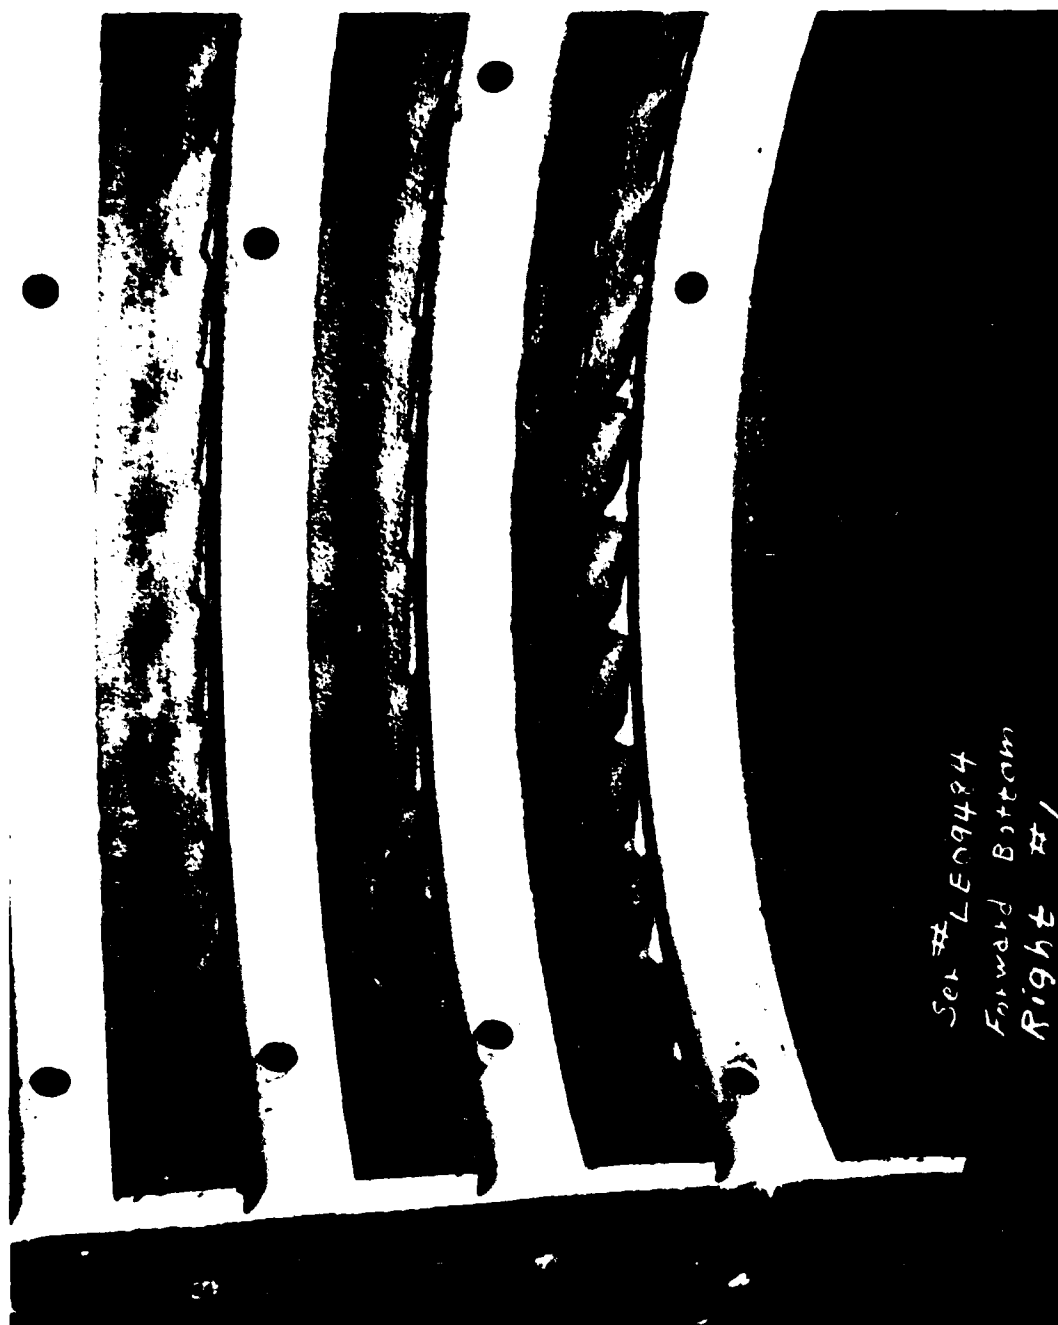
Figure 28.

4. The engine was disassembled for inspection at USAADMAC after the test was terminated at 174.5 engine hours (3.6 sand hours). Figure 27 shows the general condition of the top case of the compressor. Inspection of the lower half of the compressor case revealed that it sustained far greater erosion damage than did the top half of the case. The condition of the lower half of the compressor case is shown in figure 28 (left side, forward section), figure 29 (right side, forward section), figure 30 (left side, rear section), and figure 31 (right side, rear section). The condition of the centrifugal impeller housing is shown in figures 32 and 33. The general condition of the rotor assembly is shown in figure

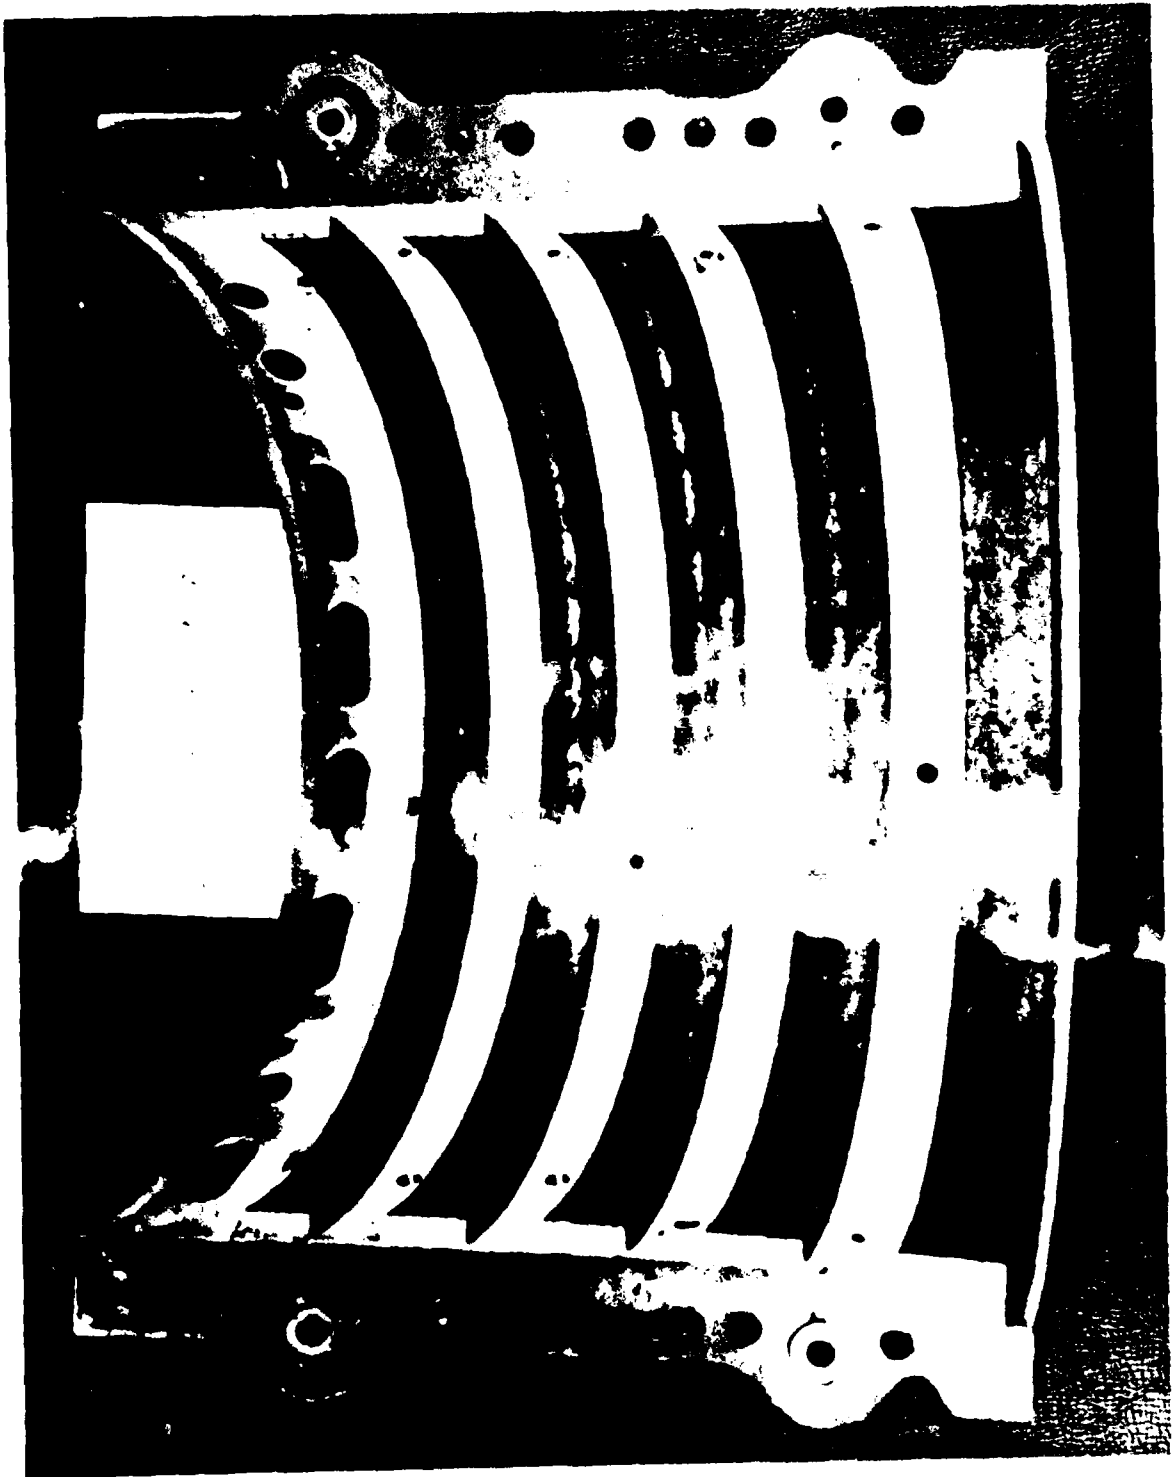
AXIAL COMPRESSOR HSG.
LOWER HALF
ENG S/N LE09484
